Investigation of the Remaining Life of an Immersed Tube Tunnel in the Netherlands

ABSTRACT: In this paper we present issues related to the performance of immersed tube tunnels in the Netherlands. A range of issues are experienced for the ageing structures including long-term settlement at tunnel joints and consequent leakage. Because of the age of these structures some important aspects are often unknown thus creating uncertainty regarding remediation measures. Having discussed general issues the paper presents a case study of the Kil Tunnel which has experienced relatively large settlements over the past 40 years. In this case a lack of geotechnical engineering information for the soils below the tunnel was identified. A geophysical survey was undertaken and this provided key insights into the ground conditions at the tunnel site.

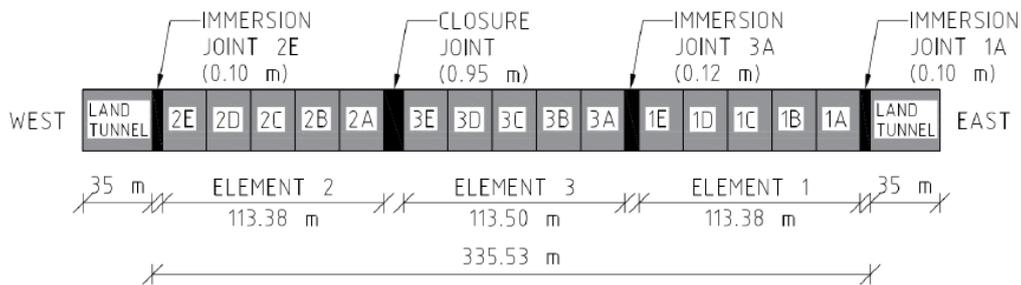
Figure 1 Long section through Kil tunnel showing the element locations, segment numbering and location of joints (from Rijkswaterstaat 1974)

The Kil tunnel with a length of 405m carries a two-lane highway and bicycle lane (each direction) under the Dordtsche Kil near Rotterdam. In cross-section the tunnel is a double tube concrete structure with a width of 31m and height of 8.75m. The immersed section is primarily composed of three elements, each approximately 113.5m long, with an end (land tunnel) of 35m at each end, See Figure 1. Each element was formed by joining five individual segments in a dry dock. The elements were then transported to site and connected in-situ at immersion joints. The system is sealed at the closure joint.

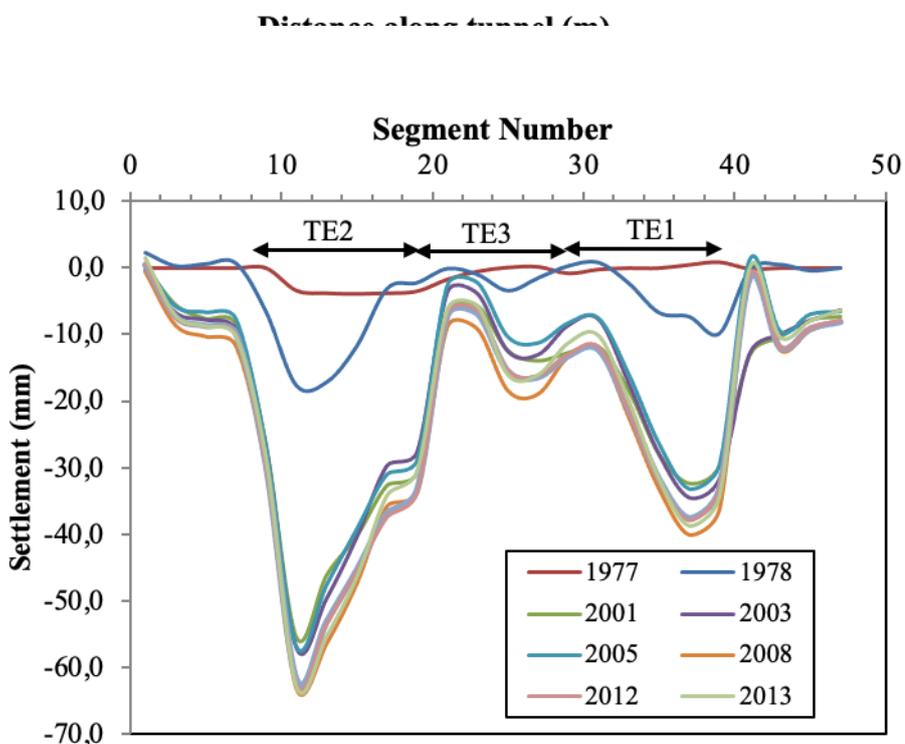
The tunnel in common with many others of this type constructed in the Netherlands has ongoing issues with settlement and leakage. Displacement measurements made throughout the operation of the tunnel are summarized in Figure 2. Linear variable displacement transducers were installed on the tunnel at the junction between segments. Initial movements were small, less than 5 mm and were concentrated in element 2. During maintenance work in 2001 significant quantities of sand was found in the pumping chamber and cracks were noticed in the wall between segments 2C and 2D, See Figure 3. Settlement measurements showed that significant settlements occurred between 1977 and 2001, forming a quite distinct pattern, whereby settlements were concentrated in elements 1 and 2, with element 3 exhibiting relatively small settlements. Unlike other tunnels, the settlements at the Kil tunnel were not concentrated at the immersion joints, rather on segment joints.

- There are very soft near surface soil zones (dark blue) evident in the profile, beneath element 2, Segments 2b-2E (See Figure 6b) and under element 1, Segment 1b. The location of the soft deposits correlates well with the observed settlement profile of the tunnel, See Figure 2 suggesting these low-stiffness zones are responsible for the unusual profile observed.
- Using Equation 1 to convert shear wave velocity to soil stiffness suggests that the near surface stiffness of the soil beneath element 1 ($V_s \approx 270$ m/sec) is nine times higher than in these soft zones ($V_s \approx 90$ m/sec) which is generally in keeping with the magnitude of settlement evident in the different elements.

Considering the settlement pattern with time in Figure 7 and the settlement pattern in Figure 2, the accumulated settlement against time shows ongoing settlements that are highest in the region where the soft zones are evident and much lower where stiff soils exist. Settlements at all locations are continuing with time. Whilst the soft ground is clearly affecting the magnitude of settlement, the mechanism is not known. Two potential causes are considered, cyclic loading and creep. Cyclic loading of the Kil tunnel could arise from a number of sources, differential water pressures due to tidal effects, traffic loading, temperature etc. Creep or strain under constant load is a phenomenon affecting most materials, in this case it could arise due to creep of the foundation soil or concrete creep, particularly in the slopes segments 1 and 2 in the Kil Tunnel. For both cyclic loading and creep effects on soils the overall behaviour can be described by simple power-law expressions (Gavin et al. 2009 and Li et al. 2015) shown in Figure 7 assuming either plastic hardening during cyclic loading or time dependent creep reducing settlement with time. For all locations in Kil Tunnel these models suggest maximum total settlements in the range 10mm to 90mm up to the 100-year design life of the structure.

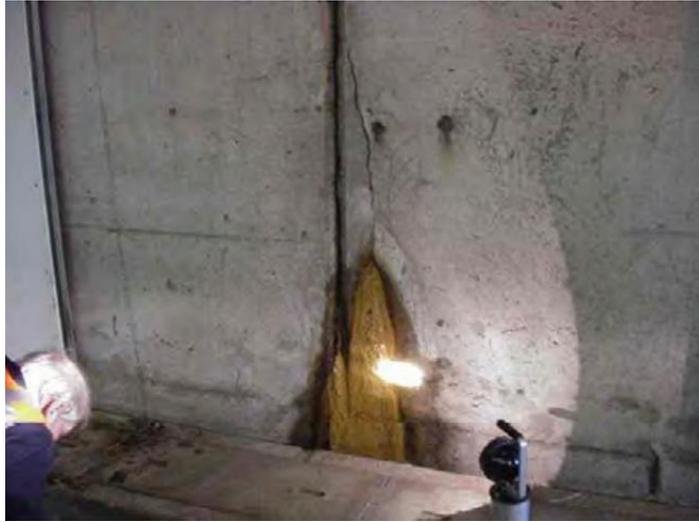
Figure 3 Cracking at segment joint

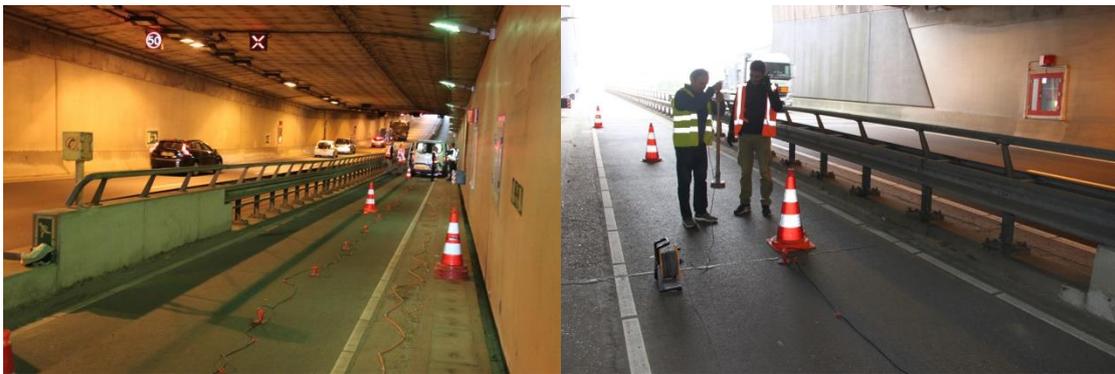
Figure 4 (a) Site test set-up (b) Test underway

Whilst some embedment of the geophone in soils is necessary to ensure good contact, on road and concrete surfaces this is not possible and contact was ensured using a steel plates as shown in Figure 4a. A 6 kg sledgehammer was used to generate the surface waves which were in turn detected by 40 No. 10 Hz geophones placed at 2.5m centres, See Figure 4a. The source was located at the mid-point of the geophones, See Figure 4b. Data was recorded with a Smartsystem data logger at a sampling rate of 0.5 msec.

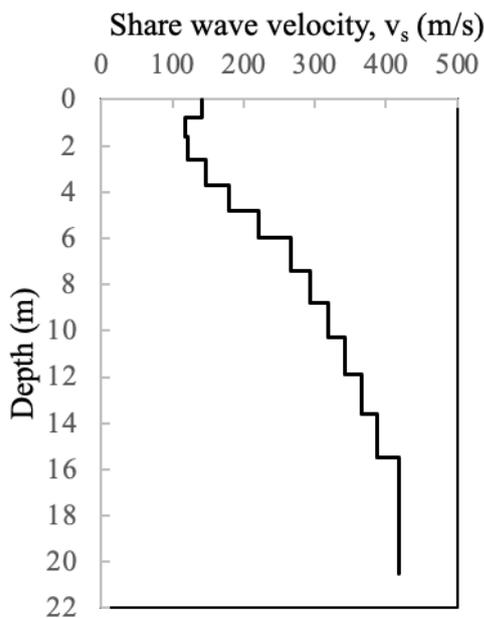
Figure 5 Example of a typical 1D shear wave velocity trace at Kil Tunnel

The Software SeisImager was used to obtain a dispersion curve from the phase velocity-frequency spectra, which was generated using a wave-field transformation method (Park et al., 1998). An example of a typical one-dimensional V_s profile measured at the site is shown in Figure 5.

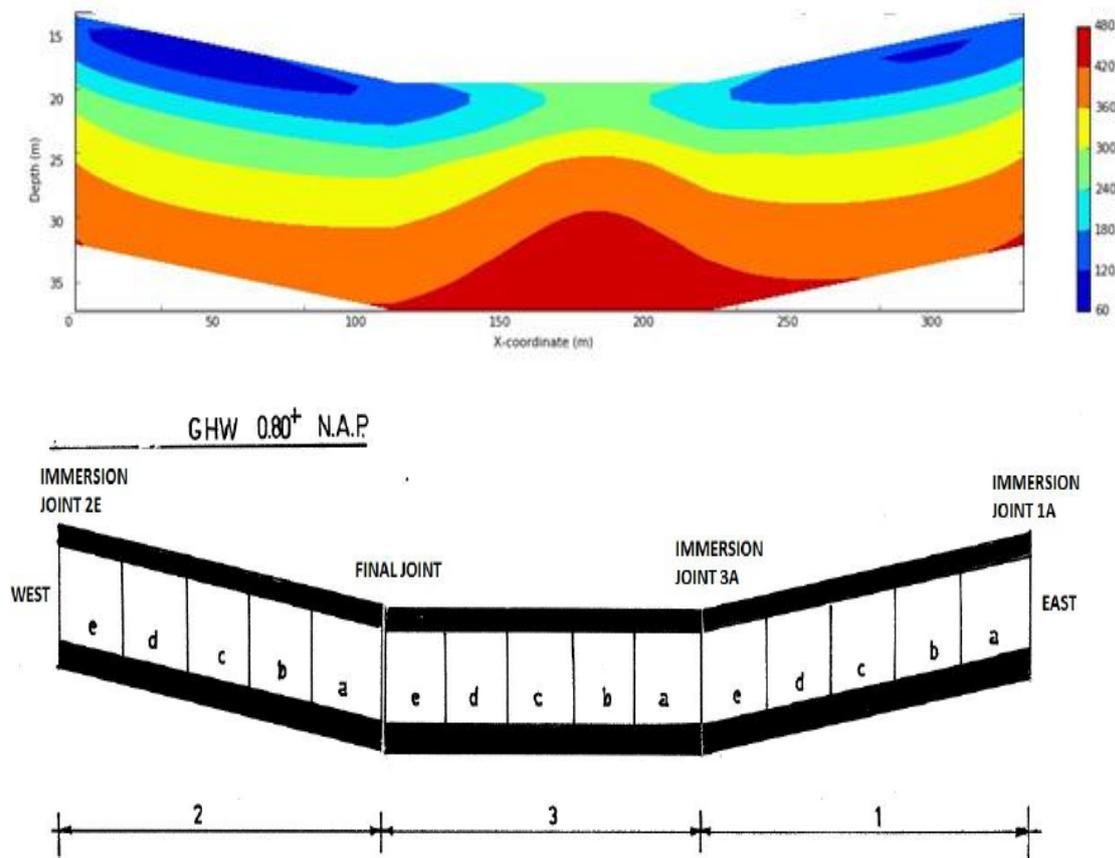
Figure 6. (a) 2D V_s profile at Kil Tunnel (b) location of segments and joints (Rijkswaterstaat 1974)

The MASW survey described in the previous section resulted in a series of 1D V_s profiles spaced at 2.5 m centres along the immersed tube tunnel. Using linear interpolation, a 2D V_s profile was created. See Figure 6a. The dark blue colour indicates low velocity (soft soils) and the red colour is high velocity (stiff soils). The darker shade the blue colour is, the softer the soil. The main results are:

A preliminary interpretation would suggest that these soft zones are potentially old deeper channels of the river that were infilled with soft sediments or perhaps areas of poorly compacted sand that was backfilled into the excavated trench prior to tunnel placement. Given that MASW is a non-intrusive method of investigating the soil it has been recommended to perform additional CPT testing to provide verification of the interpreted ground model.

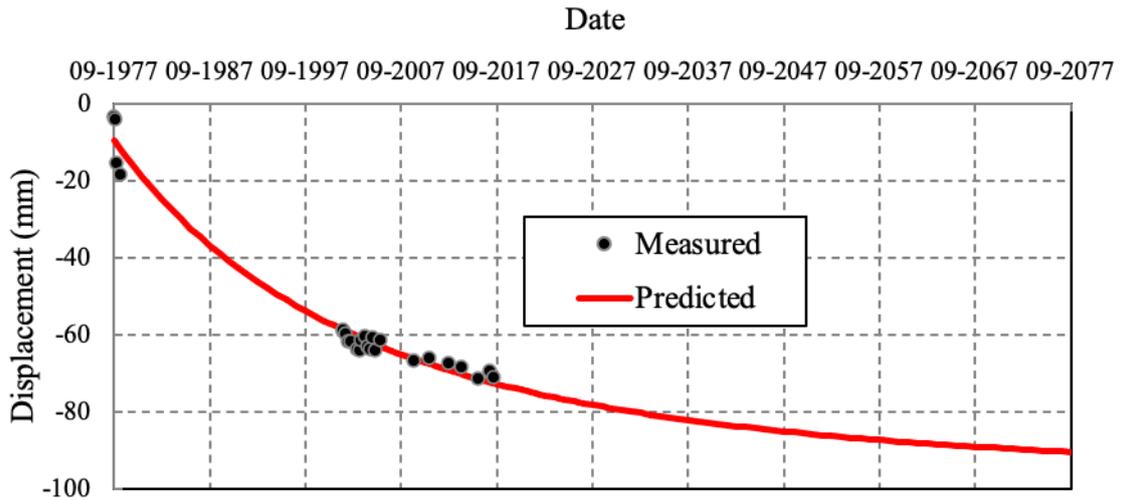
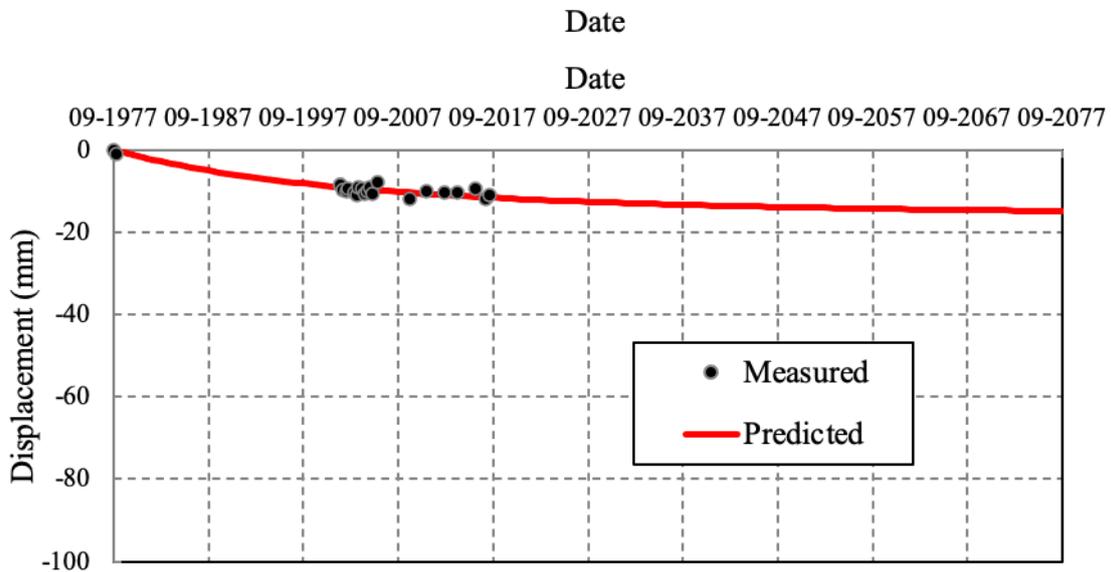
Figure 7. (a) Measured and predicted settlement for segment 2C and (b) segment 2E
